Black & Tan—Black Mixed Oak

Pioneer millworks
RECLAIMED & SUSTAINABLE WOOD PRODUCTS

CUT AND PASTE SPECIFICATION INTO APPROPRIATE CSI DIVISION

09 64 29—Wood Strip and Plank Flooring
06 42 00—Wood Paneling

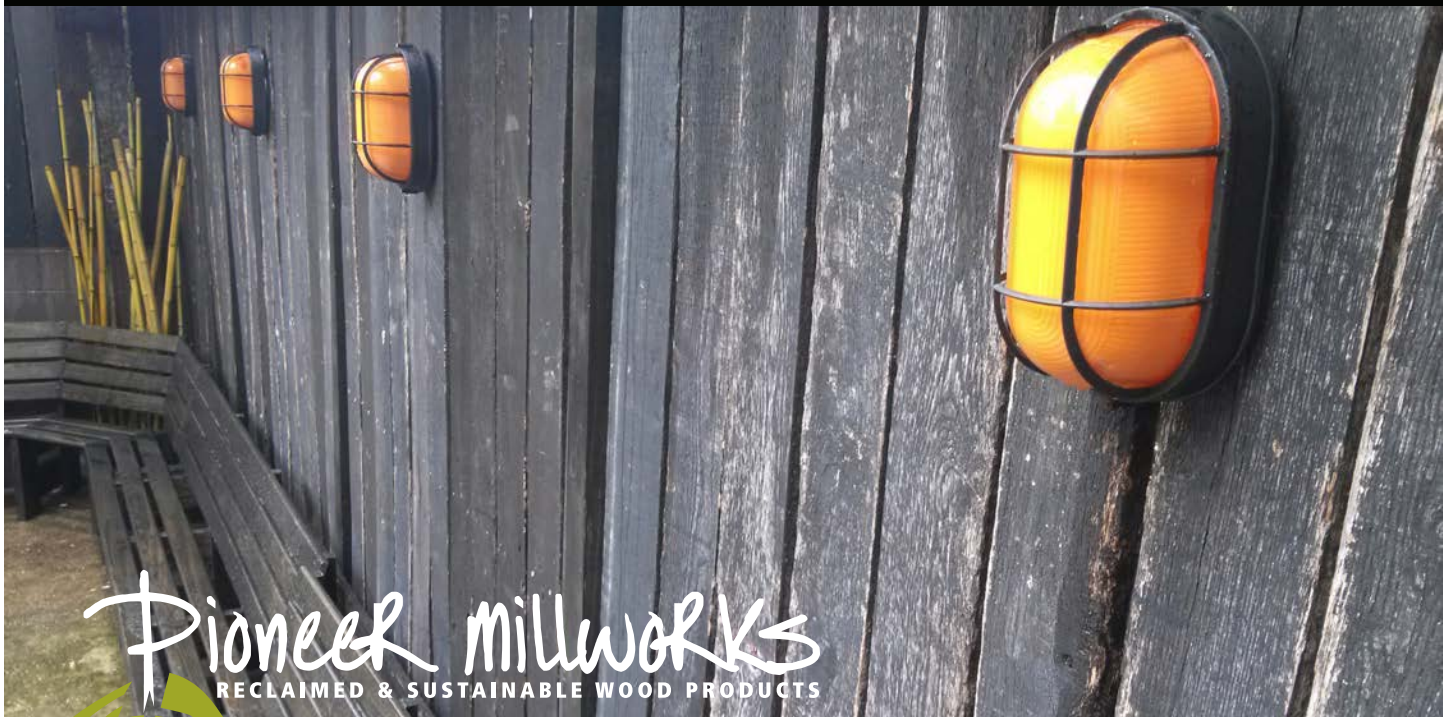
We leave the original painted surface of this Oak plank untouched, giving you the rugged texture and weathering of decades of exposure. Dark blacks and weathered greys, with occasional peeks through to the Oak underneath, this non-toxic painted waterproof coating used in agricultural settings was safe for use around the million dollar thoroughbreds that were in daily contact with it. It can be left as is, and used indoors or out.
