# Black & Tan—Tan Mixed Oak

# Pioneer Millworks

## Black & Tan—Tan Mixed Oak

7/2018

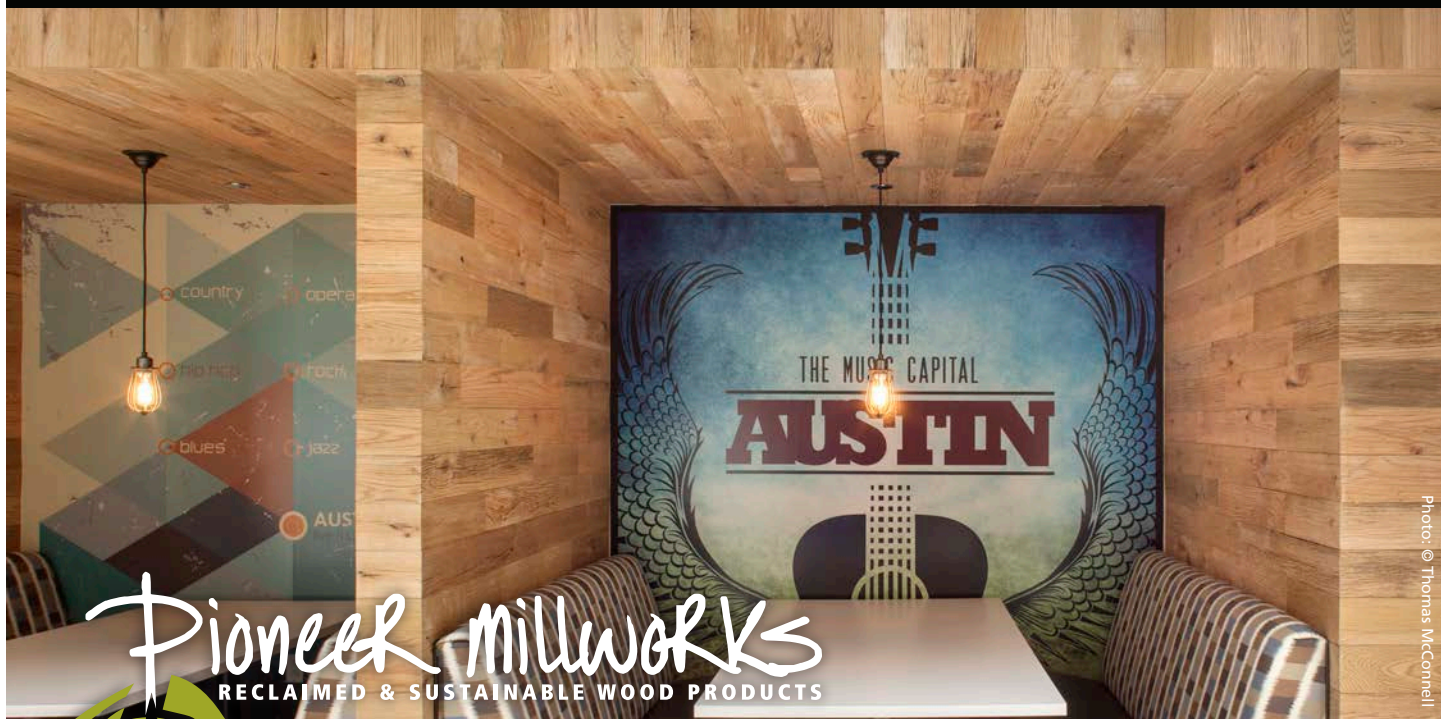
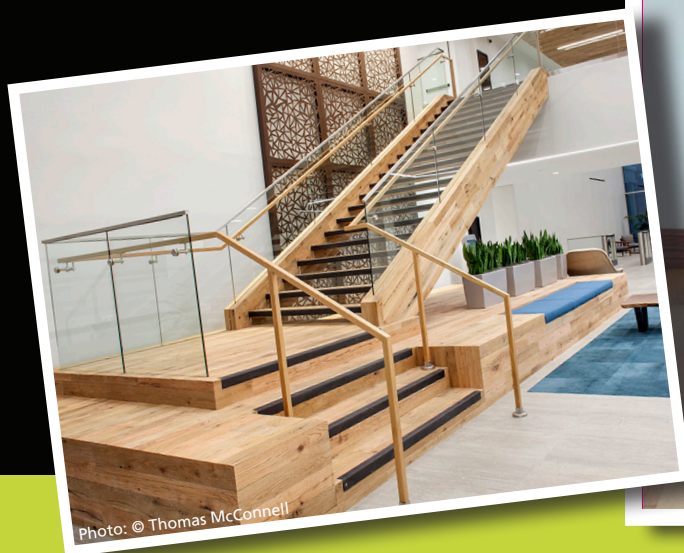
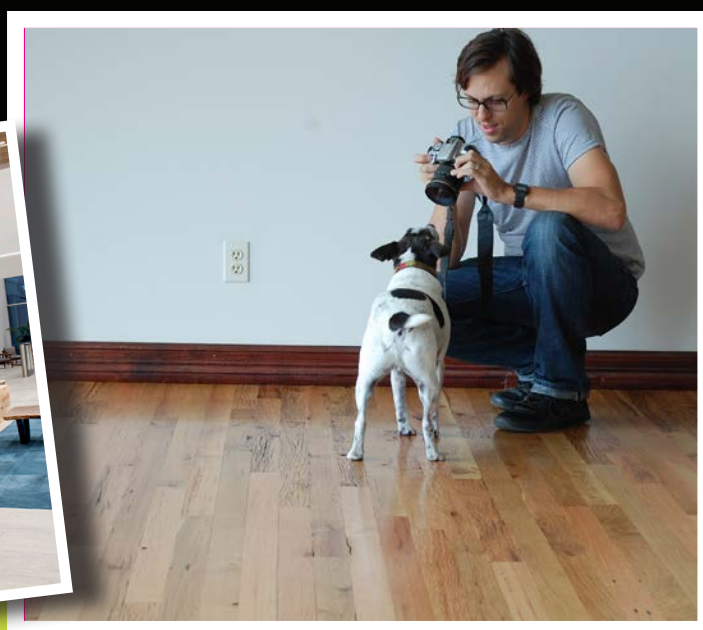
This reclaimed mix of Red and White Oak features hints of its original non-toxic black paint from its previous life as horse farm fencing deep in the grain and fissures of the smooth planed surface. An exciting blend of warm tones with varying lights and darks, you'll find occasional knots and a modest price point on these single width reclaimed planks.
